Please find the main updates of the latest bioassessment of our lake below.

- Nutrient Study Update
- Hydrilla status
- LVI (Lake Vegetation Index) results
- Status of Submersed Aquatic Vegetation (SAV)
- Status of shoreline emergent vegetation
- Recommendations for you and your lake

On **July 8<sup>th</sup>, 2015**, Seminole County Lake Management staff, Thomas Calhoun, Joey Cordell, and Sophia Pengra, surveyed the aquatic plants in **Spring Lake**.

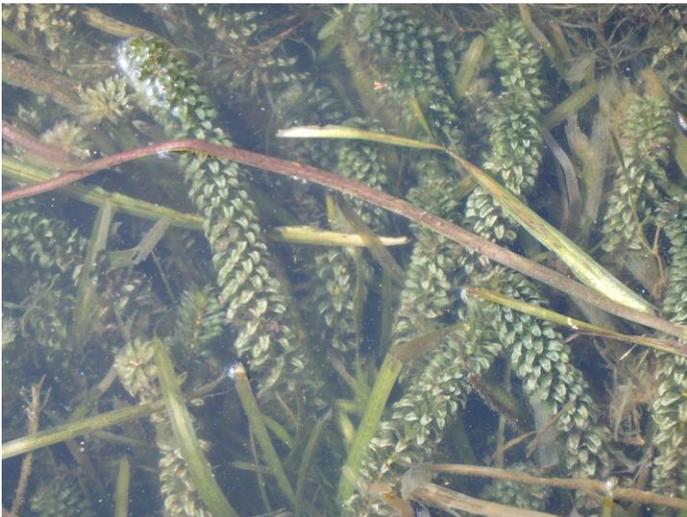
A large patch on hydrilla was found mixed in with eelgrass and pondweed at the end of the culvert on the southeast shore. This patch had a lot of new growth and will be treated soon.

**Photo: Hydrilla (invasive) mixed in with eelgrass (native).**

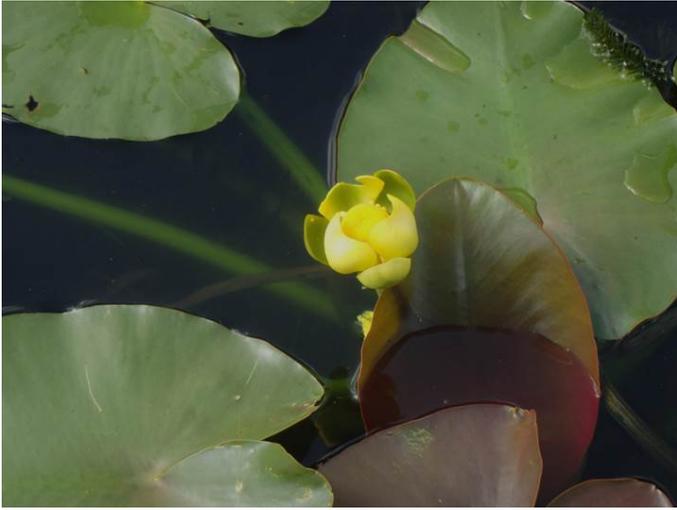
Native emergent vegetation included: pickerelweed, duck potato, fire flag, canna, flat sedge, pennywort, primrose willow, yellow cow lily, fragrant water lily, carolina willow, bulrush, and cattail. Native vegetation, especially pickerelweed and duck potato, continue to expand. Native emergent vegetation plays an important part the lakes ecosystem by filtering nutrients from runoff, protecting the shoreline from erosion and providing habitat for aquatic species.

**Photo: Yellow cow lily.**

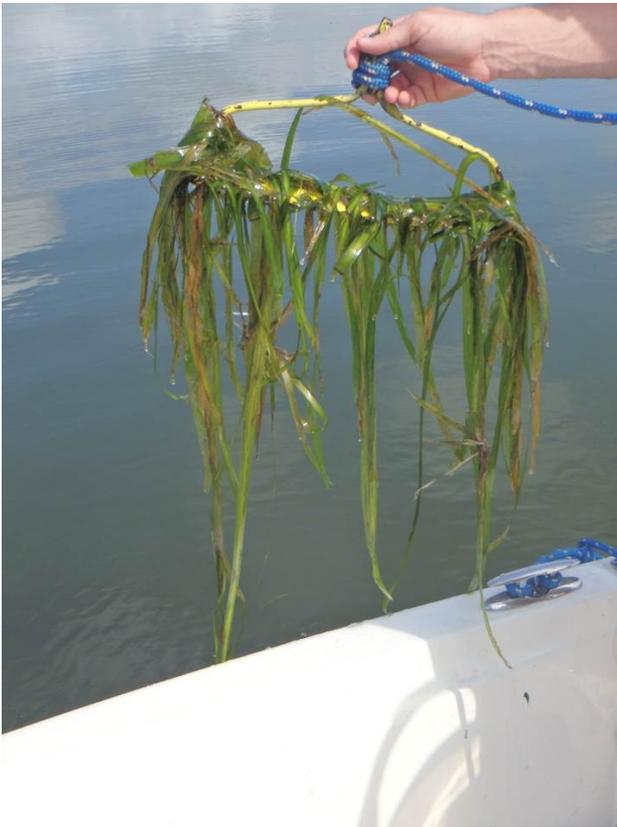
Eelgrass was the only native SAV observed during this inspection. The maximum depth for the eelgrass was 7 feet. Access corridors are open and in good shape. Patches of hydrilla that were previously observed have been treated and not present at the time of inspection.

**Photo: Eelgrass (native).**

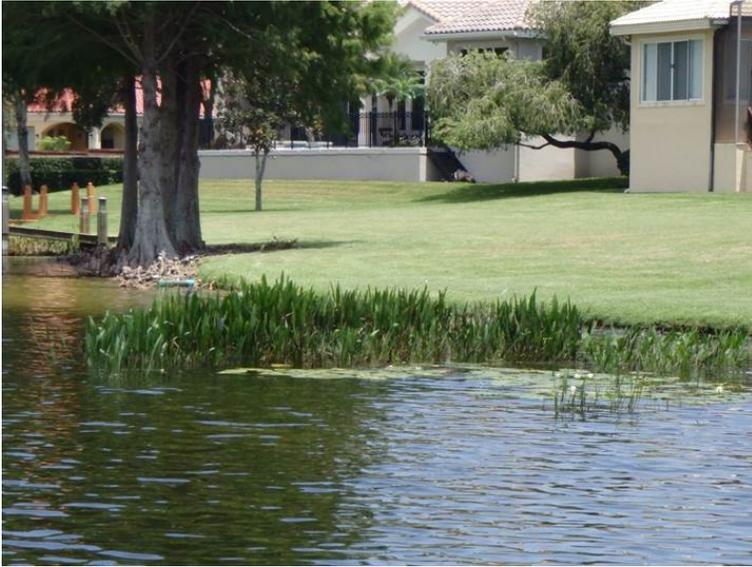
Invasive emergent vegetation found during the inspection included: alligator weed, torpedo grass, elephant ear, Brazilian pepper tree, and umbrella sedge. There are a handful of shorelines void of vegetation. It is recommended that these shorelines are planted with beneficial native vegetation. Native emergent vegetation plays an important part the lakes ecosystem by filtering nutrients from runoff, protecting the shoreline from erosion and providing habitat for aquatic species.

**Photo: Pickerelweed (native).**

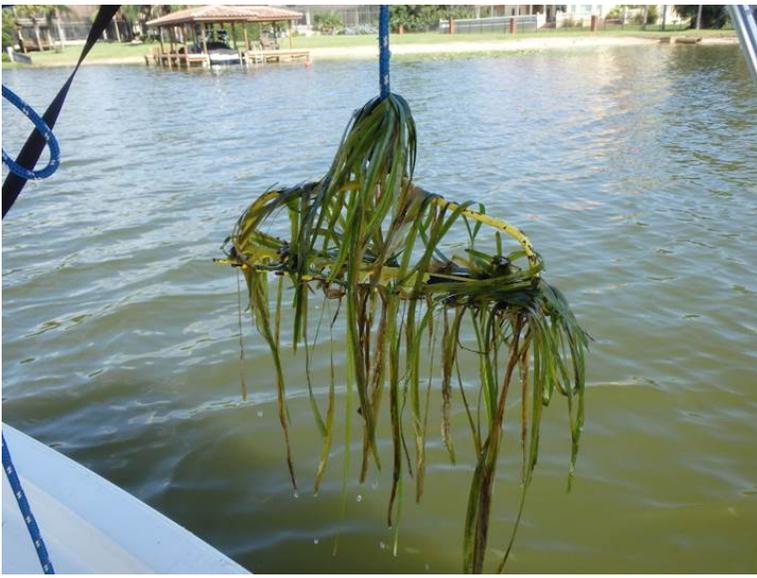
Two species of submersed aquatic vegetation (SAV) were observed during the inspection. These species were southern naiad and eelgrass. Eelgrass was the dominant SAV and was found to a maximum depth of 4.2 feet. Southern naiad was found to a maximum depth of 2.5 feet. Less eelgrass was present than at the time of the previous inspection. Access corridors were open and in good shape. No hydrilla was observed during the inspection.

**Photo: Eelgrass (native).**

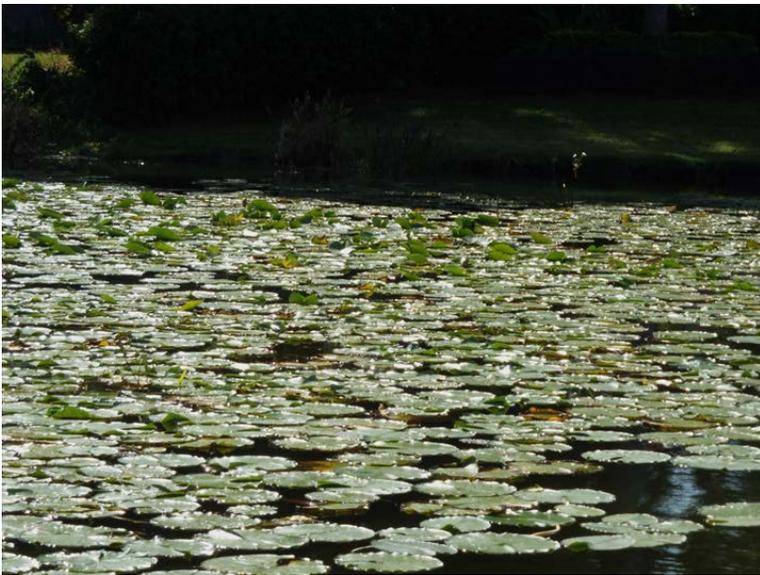
Native emergent vegetation found during the inspection included: pennywort, hempvine, yellow cow lily, fragrant water lily, water paspalum, pickerelweed, duck potato, Carolina willow, bulrush, cordgrass, fire flag, cattail, and iris. The abundance of emergent vegetation on Spring Lake was very low. Emergent vegetation is important to lake systems as it acts as a filter for nutrient runoff from surrounding yards. Planting native vegetation is an easy and effective way to improve the water quality of the lake. It is also effective at reducing shoreline erosion.

**Photo: Yellow cow lily.**

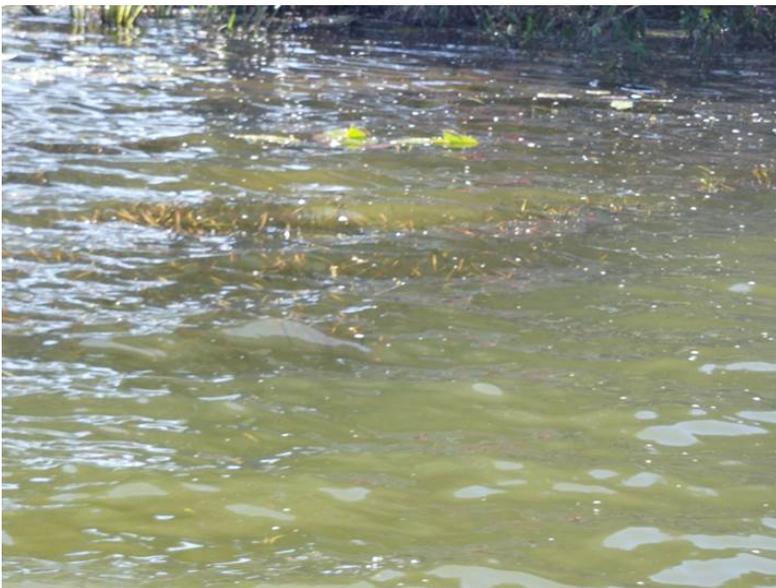
Three species of submersed aquatic vegetation (SAV) were observed during the inspection, including: roadgrass to a depth of 1 foot, baby's tears to 1 foot, and eelgrass to 5 feet. The presence of eelgrass has slightly declined since the previous inspection. The access corridors were open and in good shape. No hydrilla was seen during the inspection.

**Photo: Eelgrass (native).**

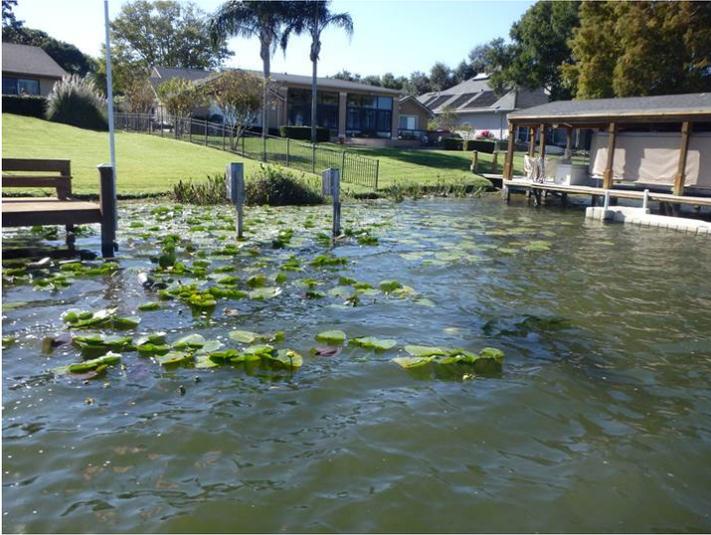
Native emergent vegetation found during the inspection included: bur-marigold, sawgrass, pennywort, hempvine, yellow cow lily, fragrant water lily, pickerelweed, duck potato, carolina willow, bulrush, fire flag, and cattail. Some pickerelweed and bulrush are experiencing a seasonal die-back but should return during the spring.

**Photo: Yellow cow lilies and duck potato.**

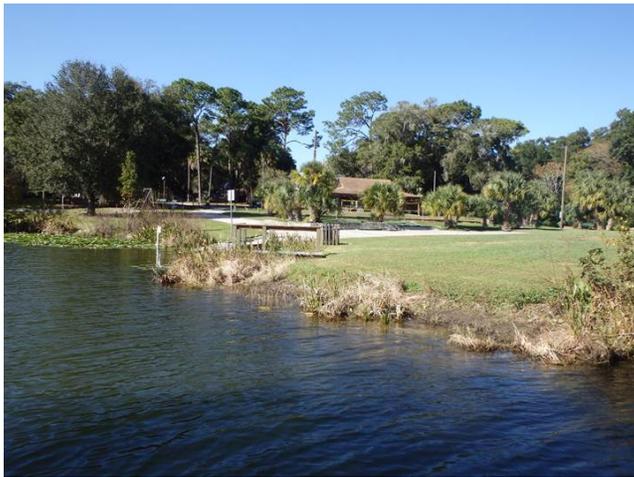
Invasive emergent vegetation found during the inspection included: alligator weed, wild taro, umbrella grass, primrose willow, and torpedograss.

**Photo: Treated torpedograss (invasive).**
